OKFACE Report #00-OK-004-01

SUBJECT: Oilfield trainee died after being struck by a bull plug, needle valve and gauge assembly blown out of a wellhead connection

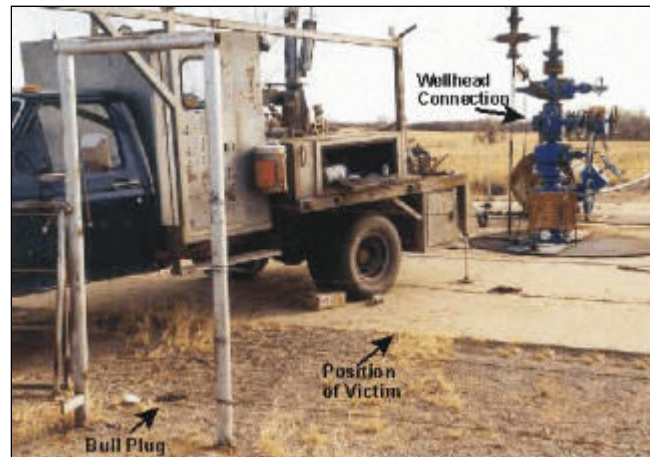
Figure 1. Position of victim in relation to the wellhead and location of bull plug after it flew out of the wellhead and struck the victim.

Discussion: The physical location of the decedent with respect to the wellhead connection was an underlying cause of the fatal incident. The victim may not have been aware that he was standing in a location subject to a flying projectile when the gauge assembly was blown out of the wellhead connection. Worksites should be laid out with vehicles and adjoining work spaces positioned out of direct line with any connections to be used during the day's activities and with hazardous areas well marked to prevent persons from inadvertently walking into an area in direct line with any connection in use. Signs or barricades that cordoned off the danger zone may have deterred the victim from being in a position where he could be struck when the

Recommendation #2: Until connections are adequately tested, the responsible employer on oil well locations should place signs or barricades in areas that lie in direct line with wellhead flanges and connections that may be subject to flying debris in the event of a system failure.

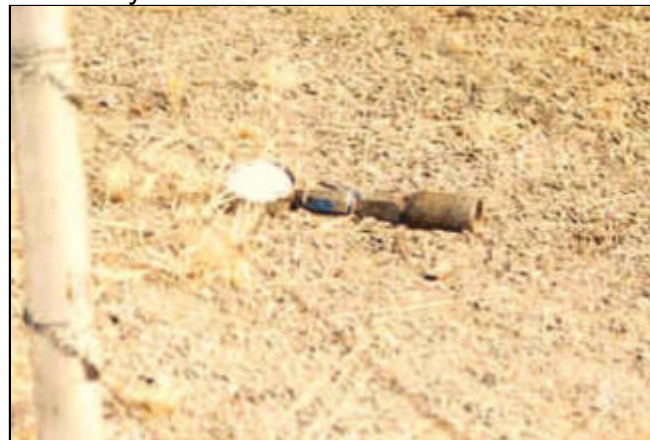
Figure 2. Bull plug, needle valve and gauge assembly

Discussion: The insertion of mismatched threads on the bull plug, needle valve and gauge assembly into the wellhead flange was an underlying cause of the fatal incident. The improper connection was reportedly identifiable by visual or physical inspection by an experienced worker. The improperly threaded connection evidences a lack of understanding regarding the equipment, the task, or the hazards presented by the use of the wrong fitting in the wellhead connection. The knowledge and skills of all workers should be assessed and adequate training provided by the employer before assigning them to perform critical tasks. Additionally, training in hazard recognition and control should be provided to all workers who work in proximity of wells. Training should address the potential for blowouts and should provide clear directions to remain outside the area directly in front of the wellhead connection.

Recommendation #5: Employers should ensure that all employees are properly trained and skilled to perform each task that they are assigned, including training in hazard recognition and control.

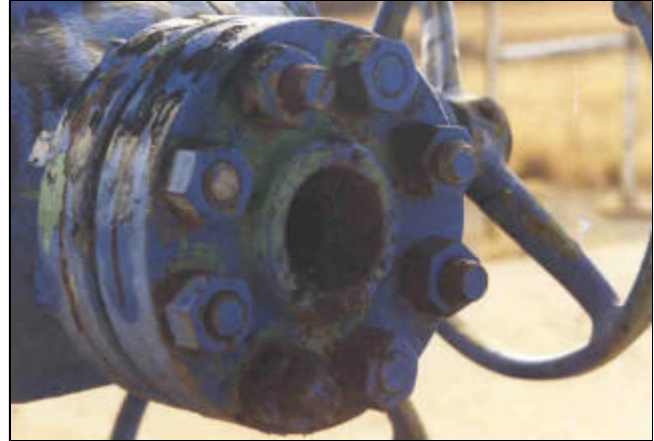
Figure 3. Wellhead Connection

Investigators determined that the chemical company operator had inserted a standard 2-inch pipe bull plug into a 2-3/8 inch eight round external upset threaded flange which may have appeared to accept the connection (Figure 3). However, only the crown of the threads were in contact with each other and none of the threads were actually engaged. The mismatched threads did not hold the assembly in place when the wellhead valve was opened. The well operator did not inspect the gauge assembly before opening the gate valve.

Discussion: The application of an improper fitting to the wellhead was an underlying cause of the fatal incident. The assumption that the gauge assembly was properly connected proved to be inaccurate, and the action to open the valve and pressurize the gauge assembly became an underlying cause of the fatal incident. The fatality may have been prevented if the gauge assembly was checked to assess its reliability before opening the well valve.

Recommendation #1: The responsible employer on multi-employer worksites should monitor critical safety activities performed by contractor employees, particularly personnel whose background and skills may be unknown or uncertain.
